# Manhole Inspection Summary

Manhole # S35Q\_\_017MH

Insp Date: **3/20/08 2:39 PM**

**Location** Address: **1024 S. HANOVER ST**

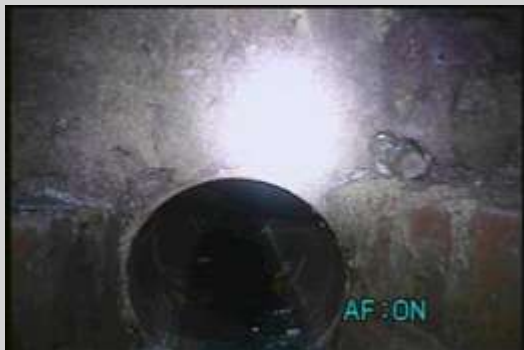
12 O'Clock Outflow

8 in. Circular Gravity Sewer  
Pipe Out @ 12 O'Clock

Pipe Material: **Clay** ☐ Pipe Lined

Invert Depth: **9.05** (ft.) Flow Characteristics: **Slow**

Deposits: ☒ None ☐ Mud ☐ Gravy ☐ Debris ☐ Grease

Infiltration: **None** Pipe Seal Cond: **Unknown**

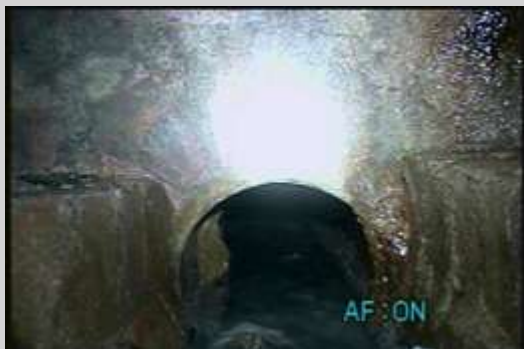
3 O'Clock Inflow

8 in. Circular Gravity Sewer  
Pipe In @ 3 O'Clock

Pipe Material: **Clay** ☐ Pipe Lined

Infiltration: **None** Pipe Seal Cond: **Unknown**
